Re: St. Lucie Unit 2  
Docket No. 50-389  
Order (EA-03-009) Relaxation Request Nos. 3 and 4  
Examination Coverage of Reactor  
Pressure Vessel Head Penetration Nozzles

**St. Lucie Unit 2 Relaxation Request No. 3  
From The First Revised NRC Order EA-03-009**

**St. Lucie Unit 2 Relaxation Request No. 4  
From The First Revised NRC Order EA-03-009**

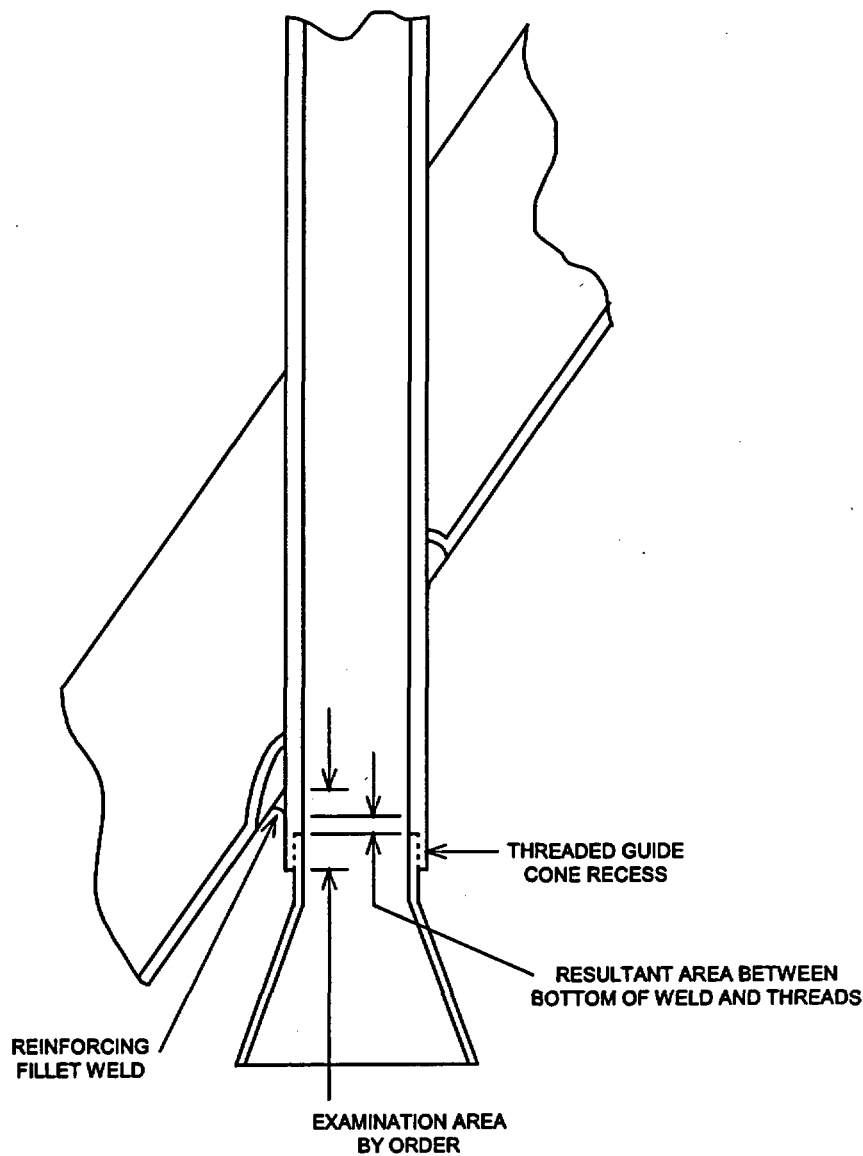
A typical example of the internally threaded nozzle, including the externally threaded guide funnel, at a high hillside angle is shown in Figure 1.

Reduced coverage below the weld on the 89 CEDM nozzles is caused by the nozzle configuration associated with an internally threaded guide funnel that limits the Ultrasonic (UT) examination or any surface examination from the nozzle ID surface. During the spring 2003 inspection, the examination coverage for 18 of the nozzles was less than 0.50 inches on the downhill side of the weld because there is less than 0.50 inches of unthreaded material below the weld in this area.

Figure 1  
Typical St. Lucie Unit 2 CEDM Nozzle Configuration

- Perform UT examination to include the nozzle base material from 2 inches above the weld down to the bottom of the weld.
- Perform UT examination from the bottom of the weld to the maximum extent possible below the weld.
- In the areas below the weld where the coverage is  $<0.50$  inches, the

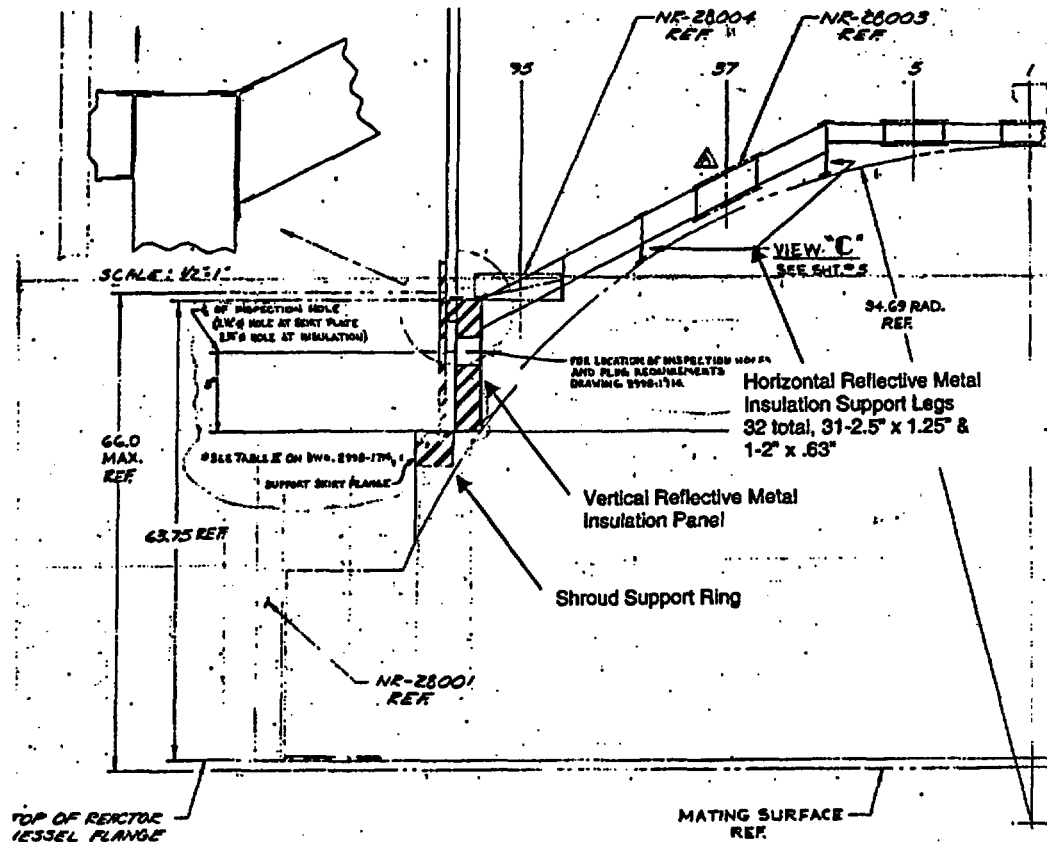
Figure 1: RPV Head Side View showing Horizontal Insulation Support Leg Locations and Vertical Insulation Panels

The scope of the examination is to perform a bare metal visual examination of 100% of the RPV head surface (including 360° around each RPV head penetration nozzle). The St. Lucie Unit 2 RPV top head surface has areas of inaccessibility due to the presence of approximately 32 horizontal RMI support legs on the RPV

head surface between the RPV head penetrations and the areas under the approximately 2¼ inches wide vertical leg of the reflective metal insulation that contacts the twelve 6-inch wide shroud lugs. These support legs (31 each at 2.5 x 1.25 inches and 1 each at 2 x 0.63 inches) represent a total area of less than 100 square inches and the vertical panels that contact the support lugs (12 each: 2.25 x 6 inches) represents 162 square inches. The total inaccessible area is less than 1.0 percent of the 39,000 square inches of RV head surface to be examined. Improving access to these inaccessible areas by removal of the horizontal panel support legs and the vertical panels, for visual examination would require major disassembly of the CEDM coil stacks and lifting of the shroud and shroud ring to allow access for the destructive RMI removal. This activity would result in a substantial increase in radiation dose and the potential for damage to removed components. The performance of this disassembly is not practical and does not enhance the quality of the examination because the RPV head penetration nozzles, where leakage would originate, are not located in or adjacent to the inaccessible area. The required 360° visual examination around each RPV head penetration nozzle is unaffected by this limitation. Also, the head surfaces immediately uphill and downhill of the inaccessible areas will be examined for evidence of boric acid leakage under the RMI. No evidence of corrosive products has been identified in past inspections.

FPL will achieve substantial compliance with the 100% requirement upslope of the outer most RPV head penetration by conducting a bare metal visual examination of the RPV head surface to the extent practical, excluding the inside of the 54 RPV stud holes. Specifically, the examination includes a visual examination of 100% of the nozzle-to-top-of-head interface region (360°) of each RPV head penetration nozzle for evidence of leakage and an examination of the bare head surface for evidence of wastage or corrosive products.
